Manhole Inspection Summary

Manhole # S51II_004MH

Insp Date: **8/1/08 10:10 AM**

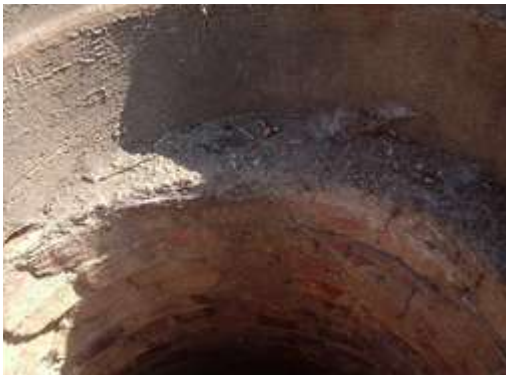
Defect 1

Infiltration: ☐ None ☐ Joint ☐ Cracks ☐ Mortar ☐ Roots ☒ **Wall**

Infiltration

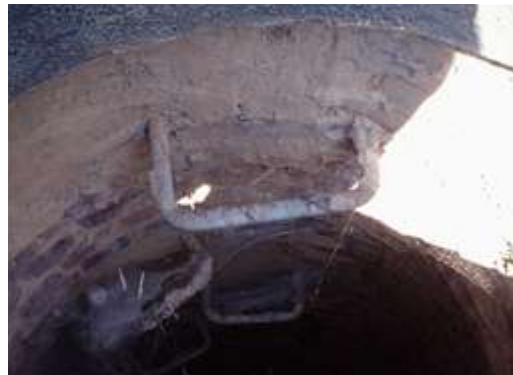
Defect 2

☒ **Leaks**

Frame leaks

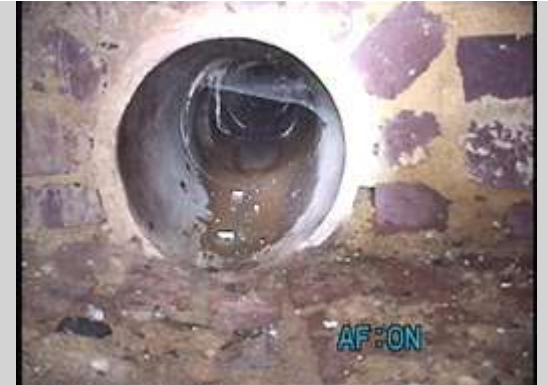
12 O'Clock Outflow

8 in. Circular Gravity Sewer
Pipe Out @ 12 O'Clock

Infiltration: **None** Pipe Seal Cond: **Sound**
